Material Migration Patterns and Overview of First Surface Analysis of the JET ITER-like Wall

***14th International Conference on Plasma Facing Materials and Components
14-17 May 2013***

- First JET ITER-Like Wall Campaign 2011-2012
- Intervention
 - Remove and replace tiles from divertor and main chamber
 - Remove and replace erosion/deposition diagnostics
 - Detailed in-vessel photographic survey

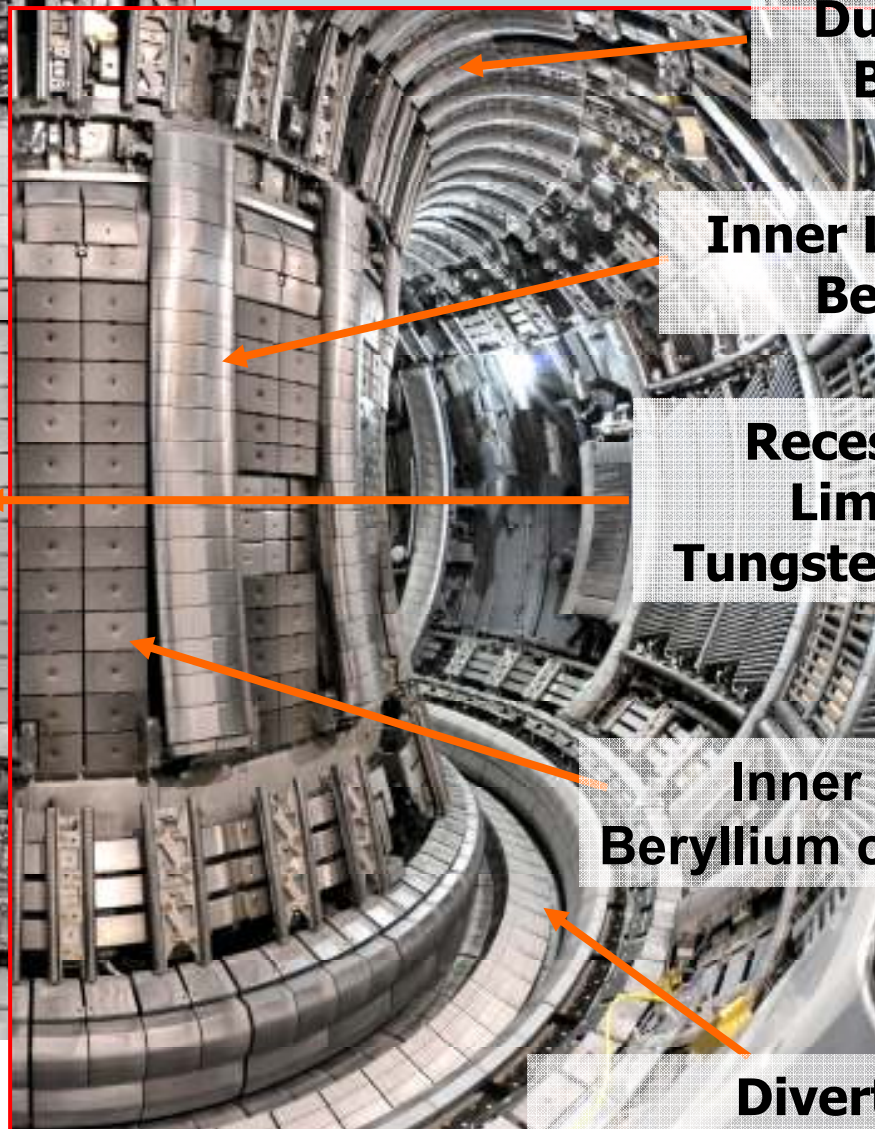
ILW – After operations

Inner and Outer Divertor tiles
Tungsten coated CFC

Divertor tile
Bulk Tungsten Lamellae

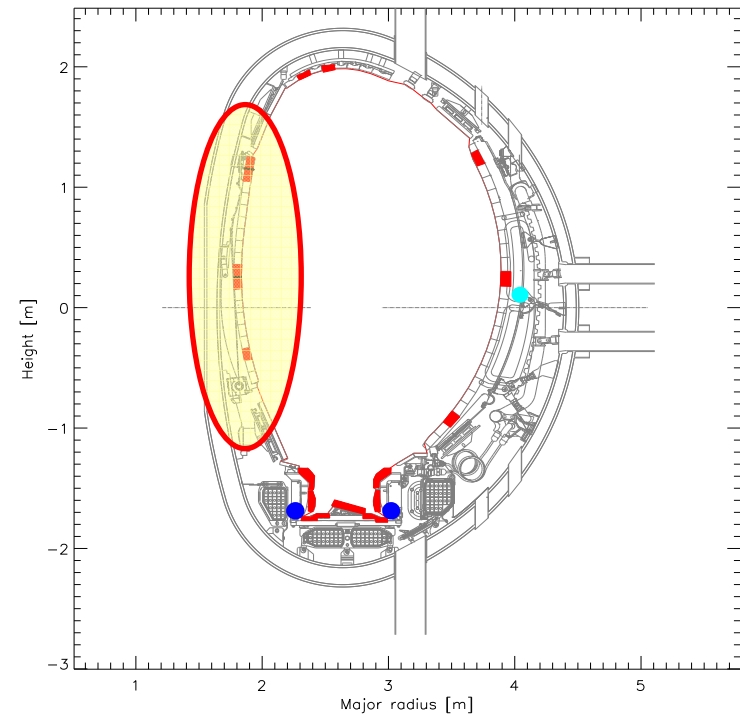
2X limiter

Arcing

dark areas, deposition
-

arc spots (orientation)
-

surface morphology changes, minor/major melting

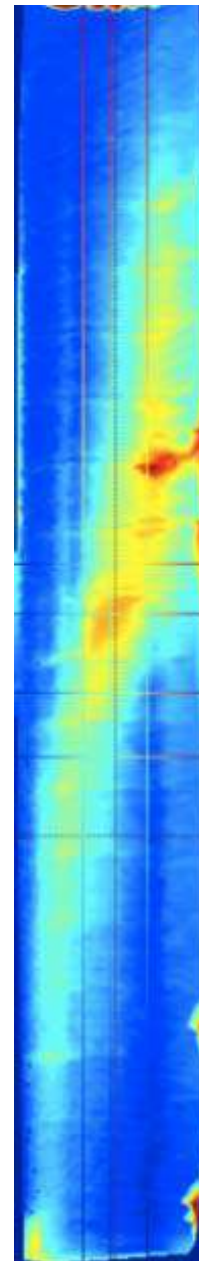
- Melting occurs during limiter phase
- More limiter only plasmas to test the wall

Heat Flux Distribution
Arnoux: PPMC14 I-14

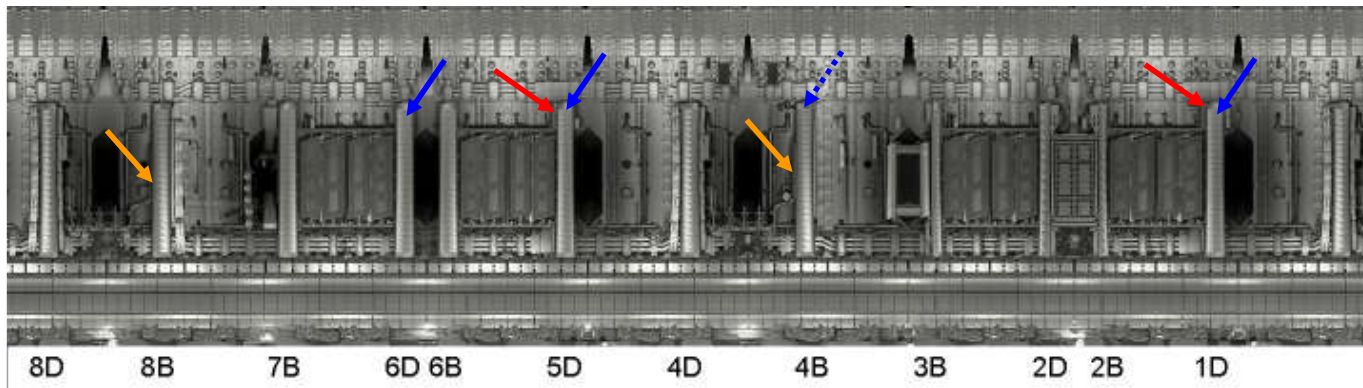
8B OPL Side Protection
W coated CFC

Example of Be deposition in the main chamber

- 3 OPL tiles taken out for post mortem analysis
- Local deposition at outer ends of tile (also on side protection tiles)
- Possible erosion from centre of tile
- Spalling of marker coating at right hand end of tile
- Analysis of OPL tiles to be completed

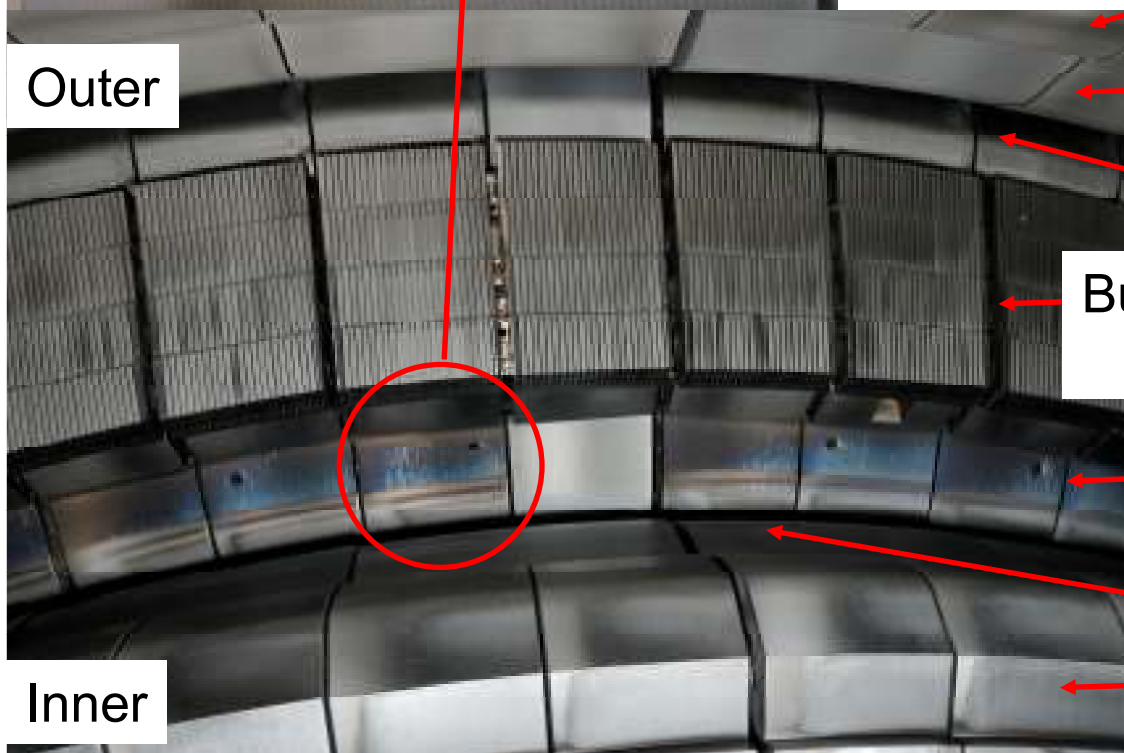
Outer

- Tungsten coatings are largely intact
- Arcing on tile 4 around whole vessel
- Delamination on tile 8 probably due to fibre orientation on top surface

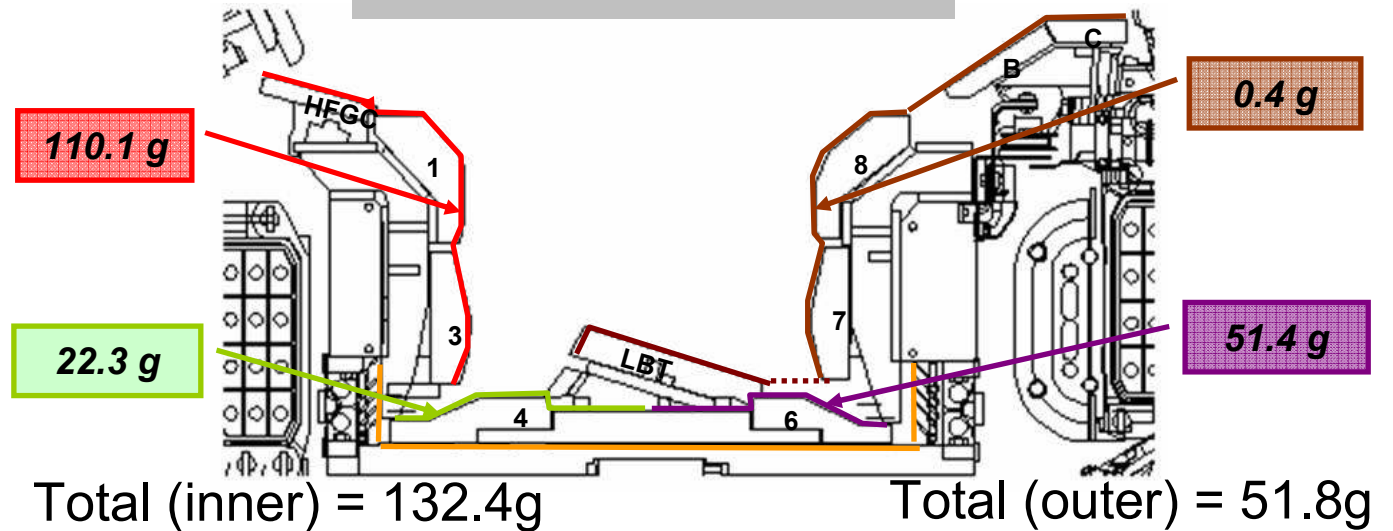
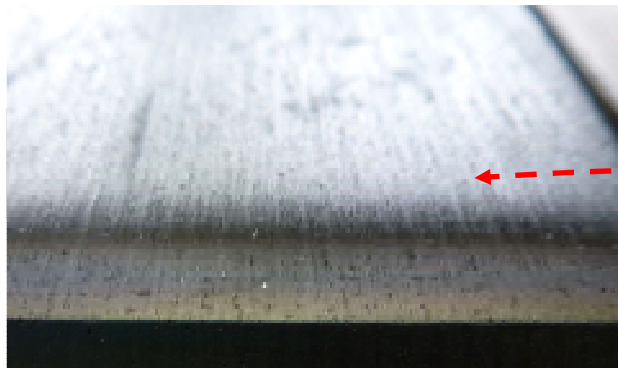
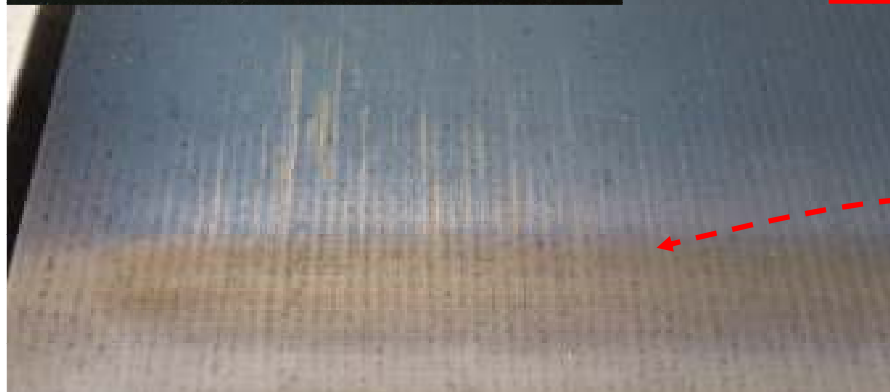
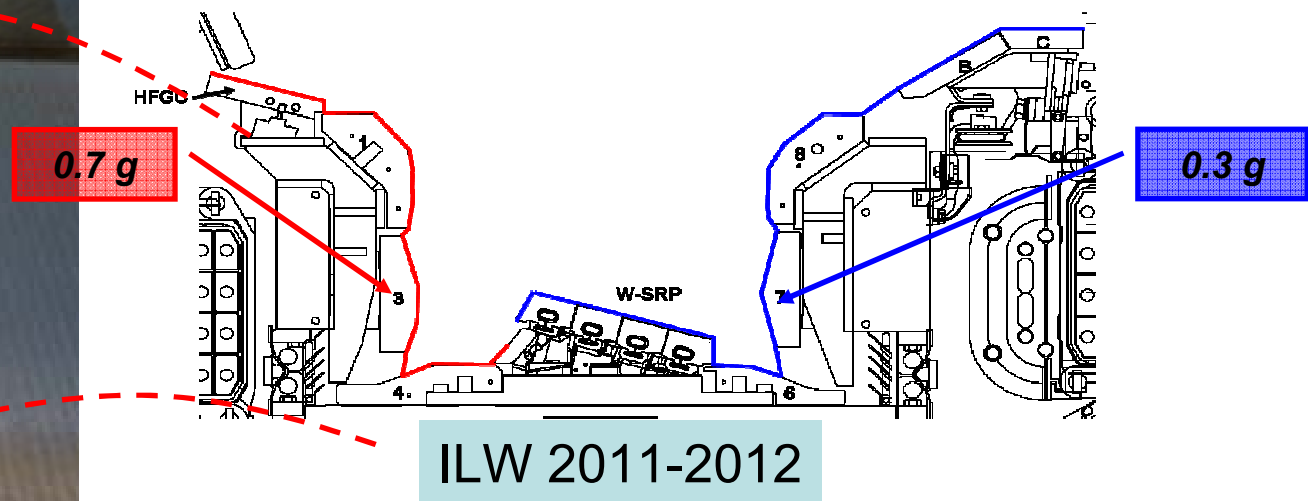
Carbon Wall 2008-2009

Dust

- Main source of dust for carbon wall was spalling deposits
- No thick deposits in divertor for ILW
- Continue to monitor dust production and layer growth in future interventions

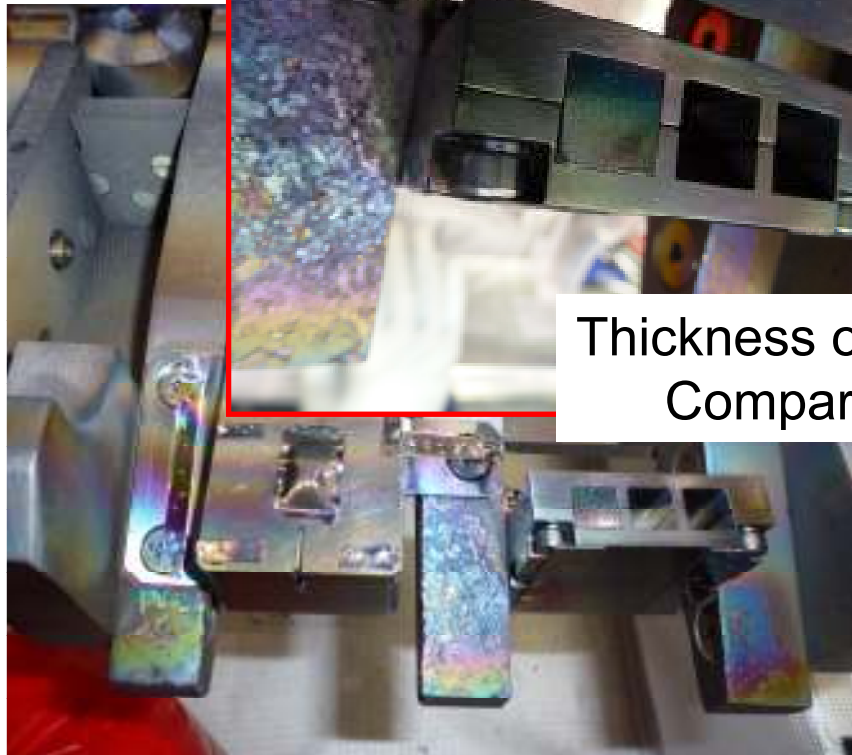
Thickness of deposits on mirrors ~500 nm
Compared to 15 μm in carbon wall

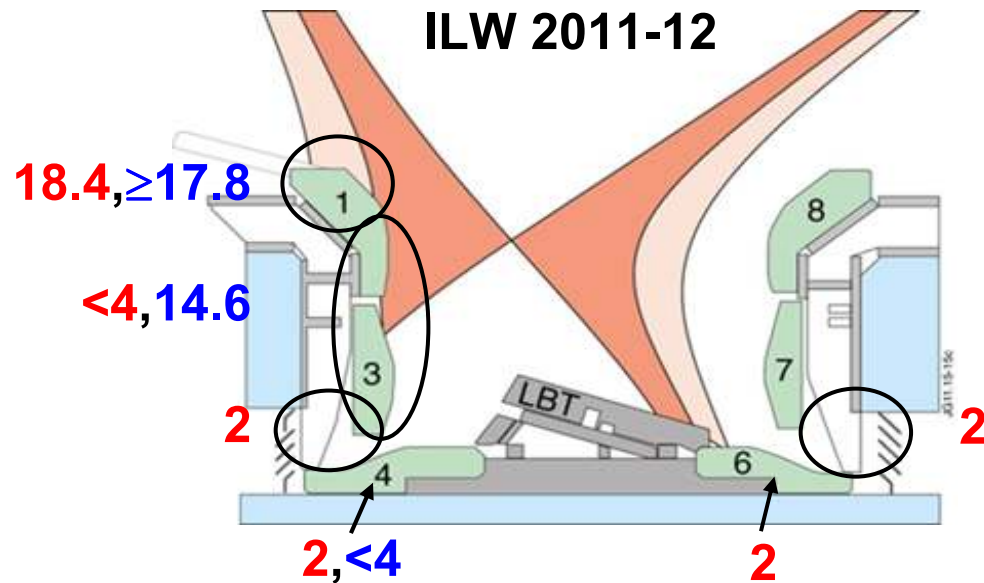
Amounts of deposit in cm^3 (extrapolated to whole divertor)

For conversion to weight (or number of atoms), may be appropriate to use density of 1 g/cm^3 for C deposits but 1.85 g/cm^3 for Be, which enhances ILW figures. Also, there may be extra Be deeper into the surface. (Coad PFMC-14)

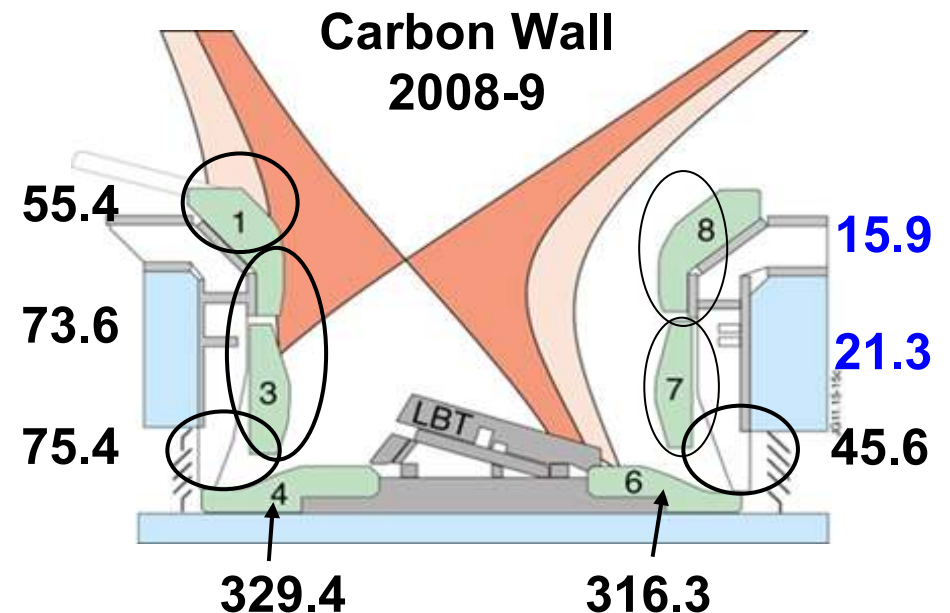
Volume of deposits determined from
Ion Beam Analysis
Cross section microscopy
Surface profiling

Volume of deposit is 2 orders of magnitude lower in the divertor base
 Only significant deposit in ILW divertor is top of tile 1 and possible band on tile 3

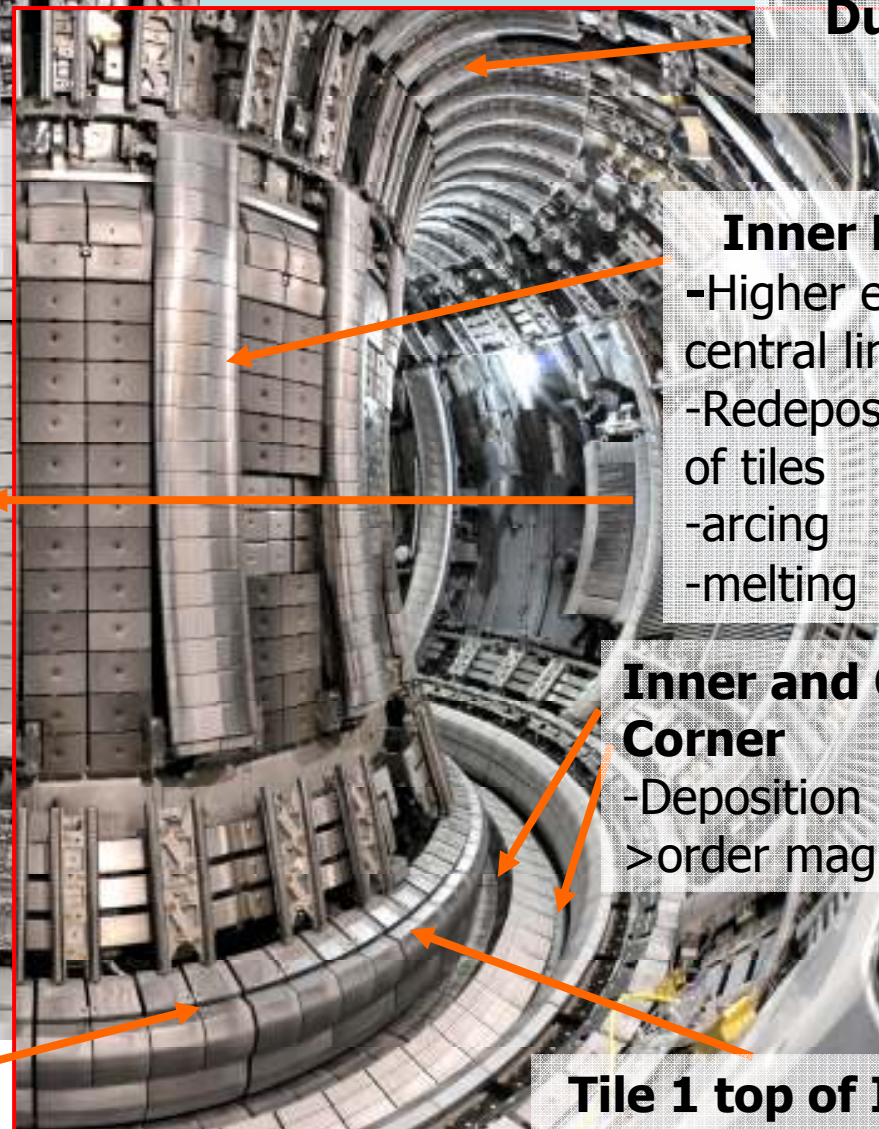
W Coatings

- Some areas of delamination but largely intact

Dump Plates

- Melting

Inner Limiter tiles

- Higher erosion from central limiter tile
- Redeposition on ends of tiles
- arcing
- melting
